Investigation of the stress corrosion cracking
susceptibility of annealed and heat treated alloy 625
castings and forgings in sea water

NAVAL ENGINEER
and
MASTER OF SCIENCE IN MATERIALS ENGINEERING

at the
MASSACHUSETTS INSTITUTE OF TECHNOLOGY
June, 1987

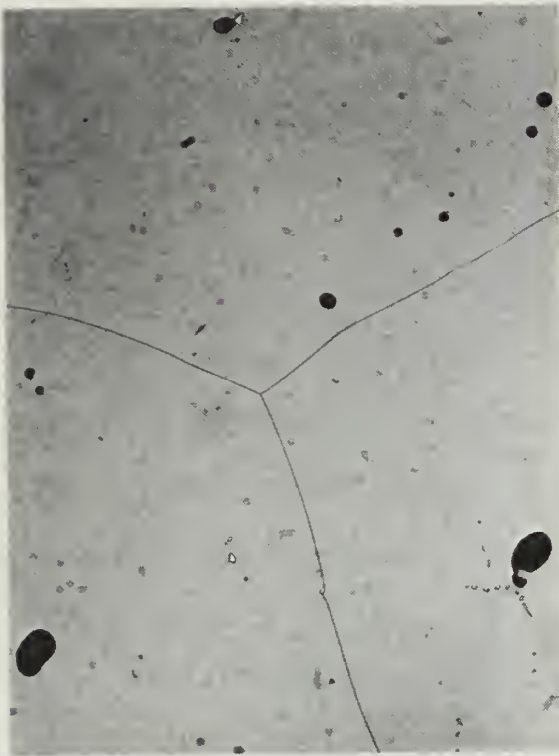
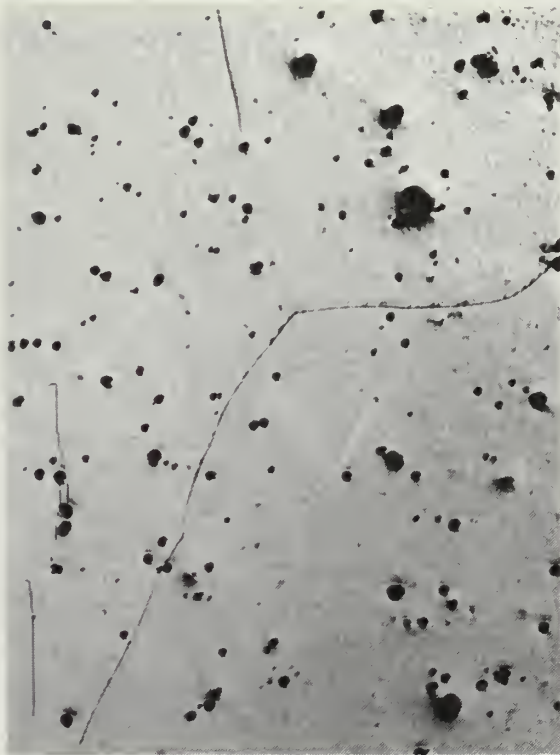
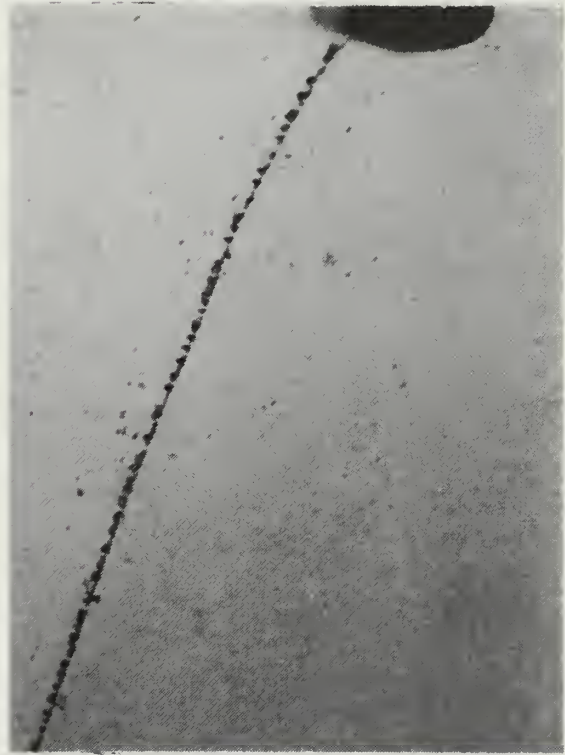
Figure 5 Photomicrographs of "Cast/Homogenized" Alloy 625

Top Left: 100X
Bottom Left: 50X

Top Right: 1000X
Bottom Right: 1000X

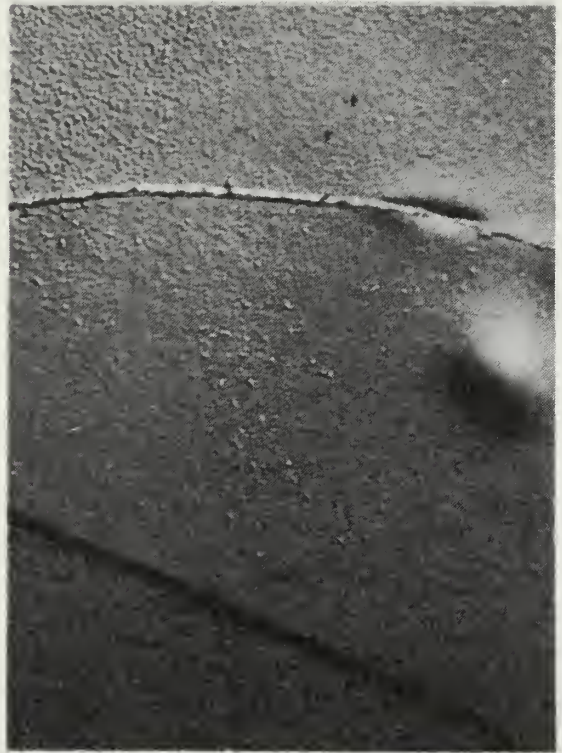
Figure 6 Photomicrographs of "Cast/Homogenized/2100°F"
Alloy 625

Top Left: 100X
Bottom Left: 50X

Top Right: 1000X
Bottom Right: 1000X

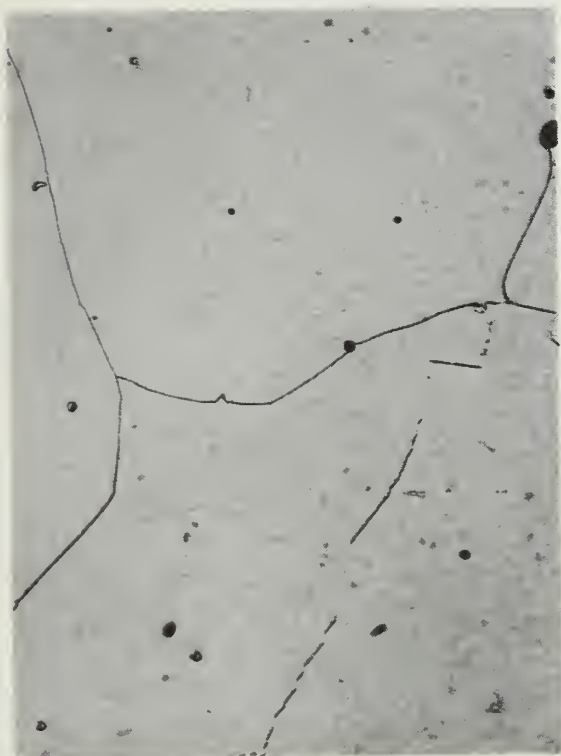
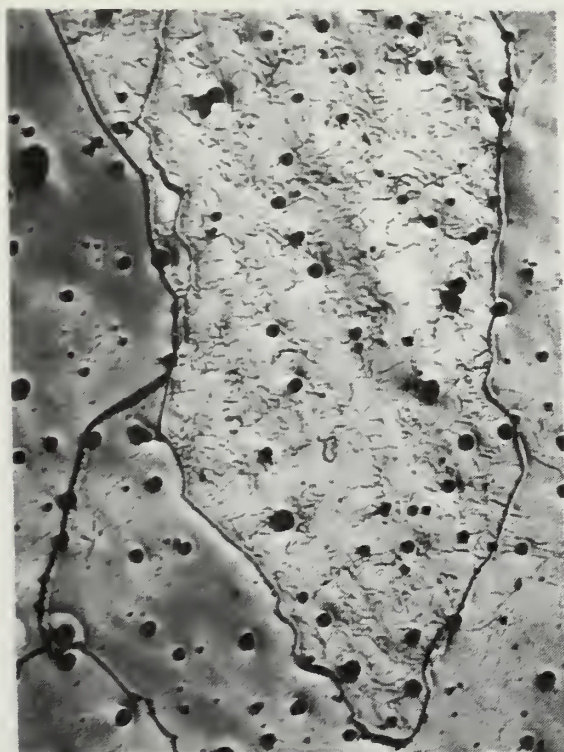
Figure 7 Photomicrographs of "Cast/Heat Treated" Alloy 625

Top Left: 100X
Bottom Left: 50X

Top Right: 1000X
Bottom Right: 1000X

Heat treating the cast material in Figure 7 caused what appears to be globular or blocky $M_{23}C_6$ carbides on the grain boundaries. The bottom photomicrographs show dislocation slip bands throughout the matrix and heavy growth along the grain boundaries.

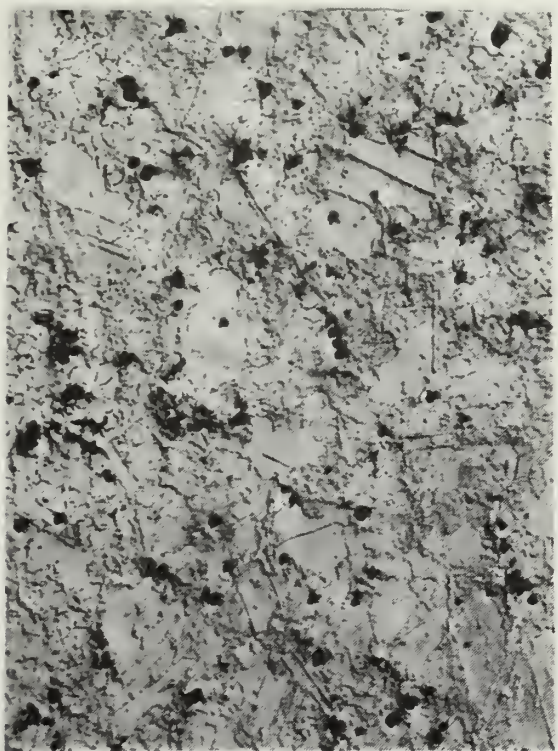
Figure 9 Photomicrographs of "Forged/Heat Treated"
Alloy 625

Top Left: 100X
Bottom Left: 50X

Top Right: 1000X
Bottom Right: 1000X

Heat treating the forged material caused some grain growth and enlargement of the grain boundary carbides as shown in Figure 9. Again the heat treatment caused dislocation slip bands to appear throughout the matrix.

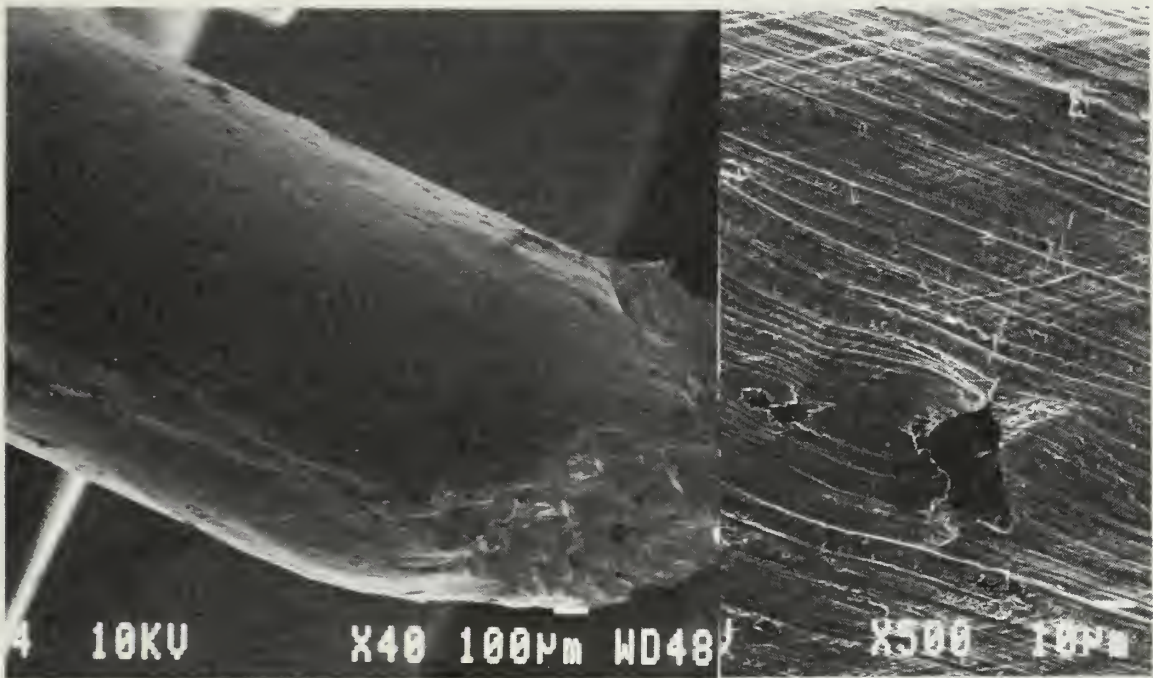
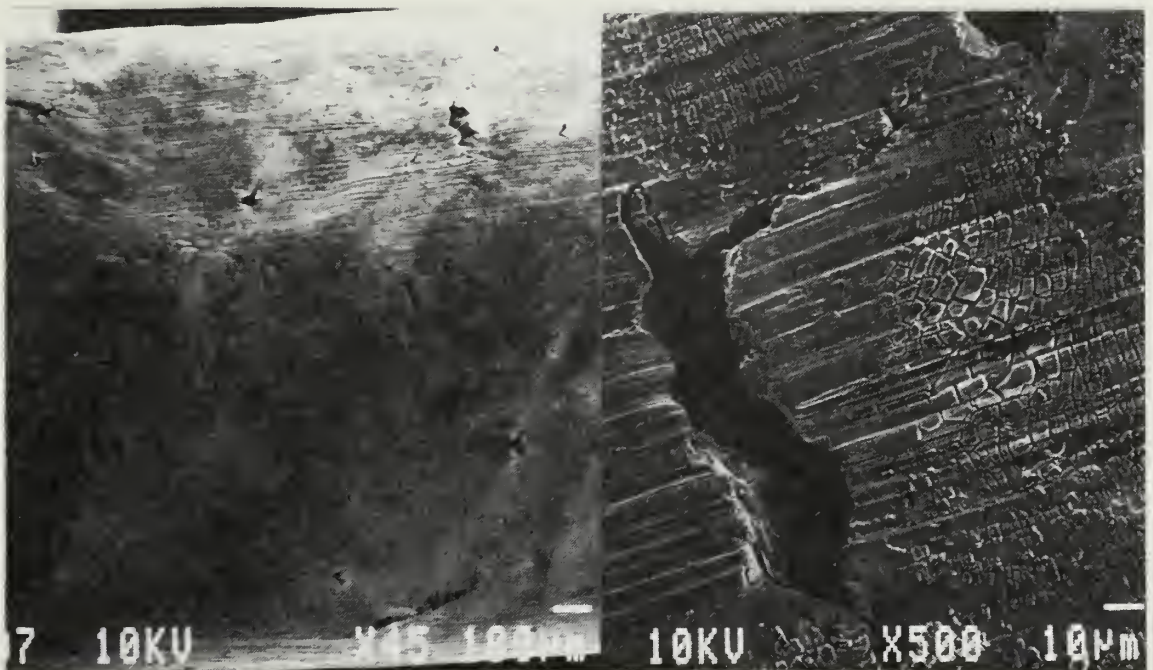
Figure 21 Photomicrographs of "As Cast" Alloy 625
Elongated Gage Length for Air and +1.0 Volt
Test Conditions - Specimens 4 and 7

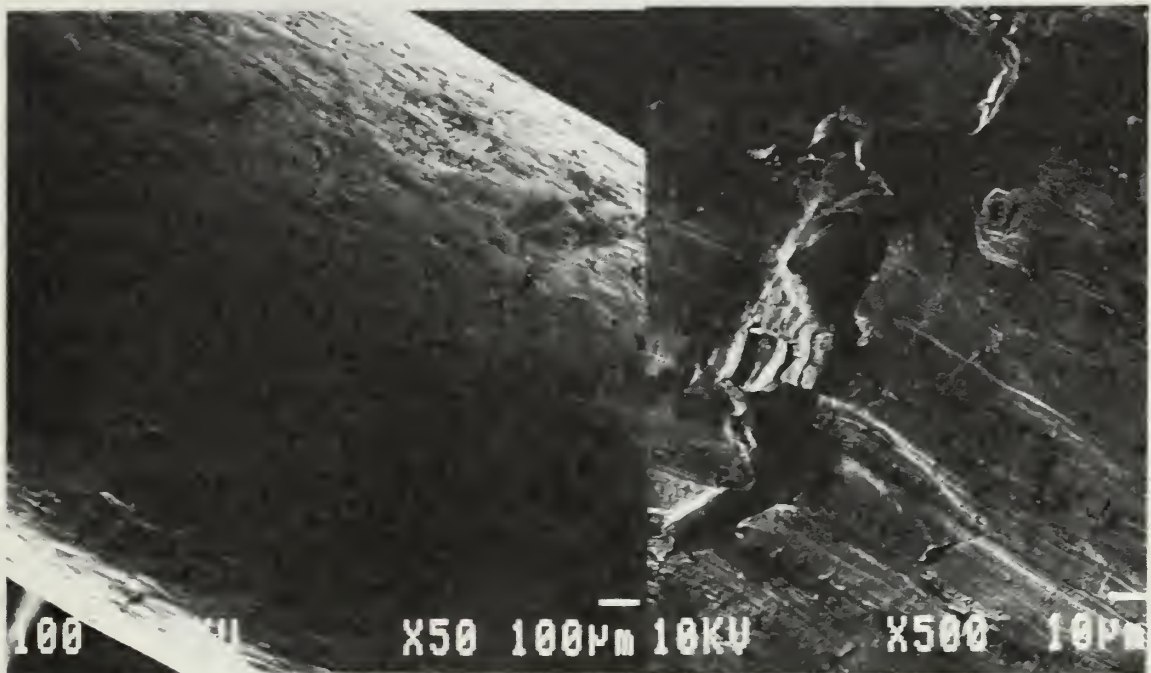
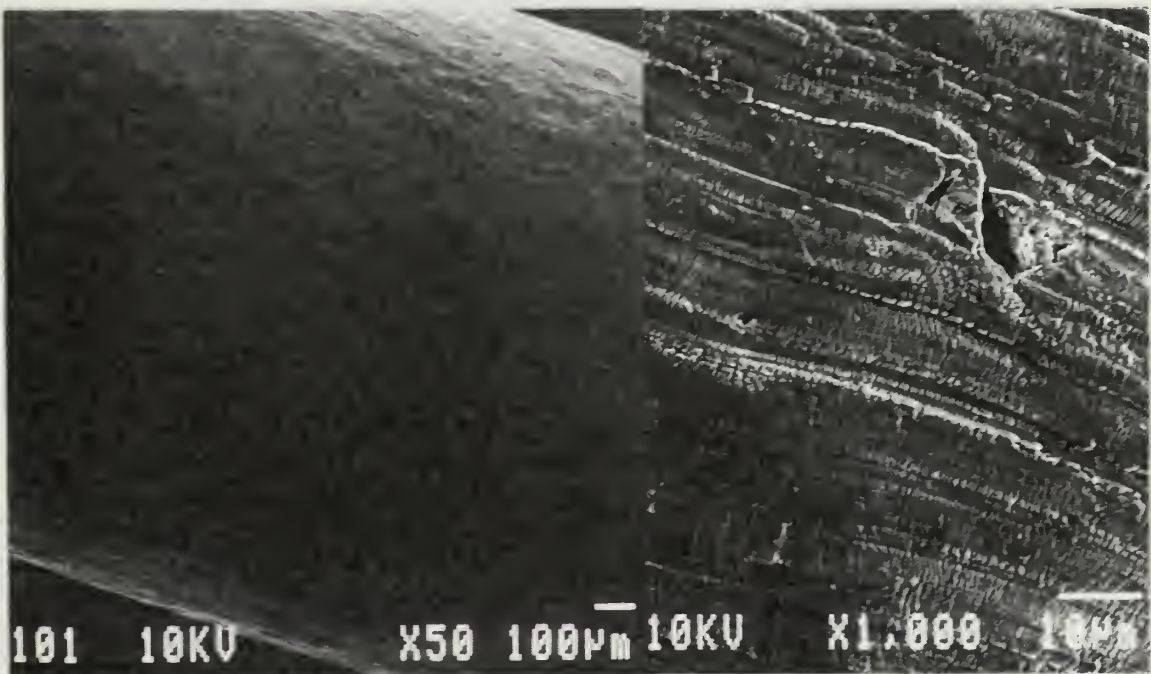
Figure 27 Photomicrographs of "Forged/Heat Treated"
Alloy 625
Elongated Gage Length for -1.0 and +1.0 Volts
Test Conditions - Specimens 100 and 101

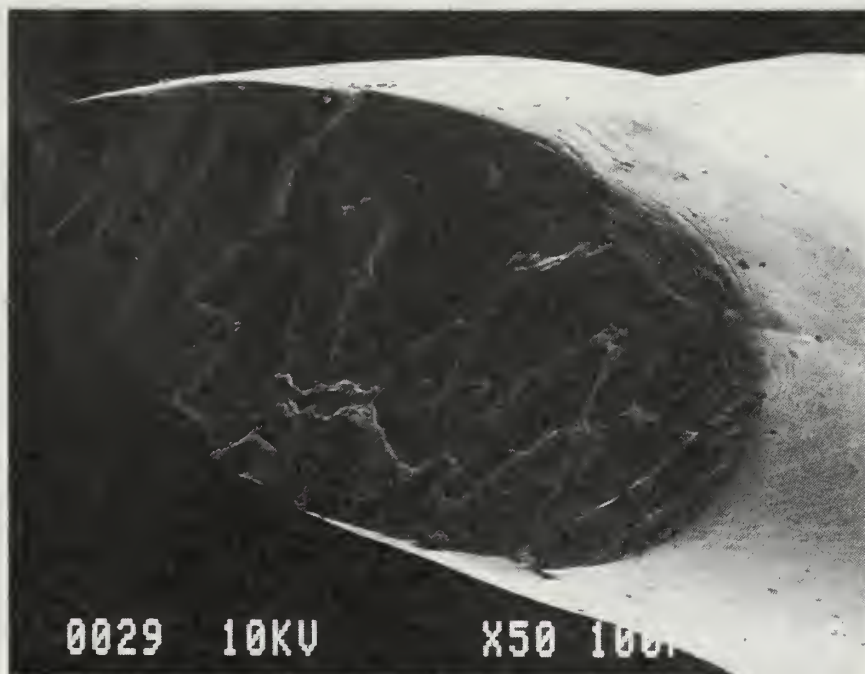
Figure 30 Photomicrographs of "Cast/Homogenized" Alloy 625
Fracture Surface for Air and +1.0 Volt Test
Conditions - Specimens 25 and 29

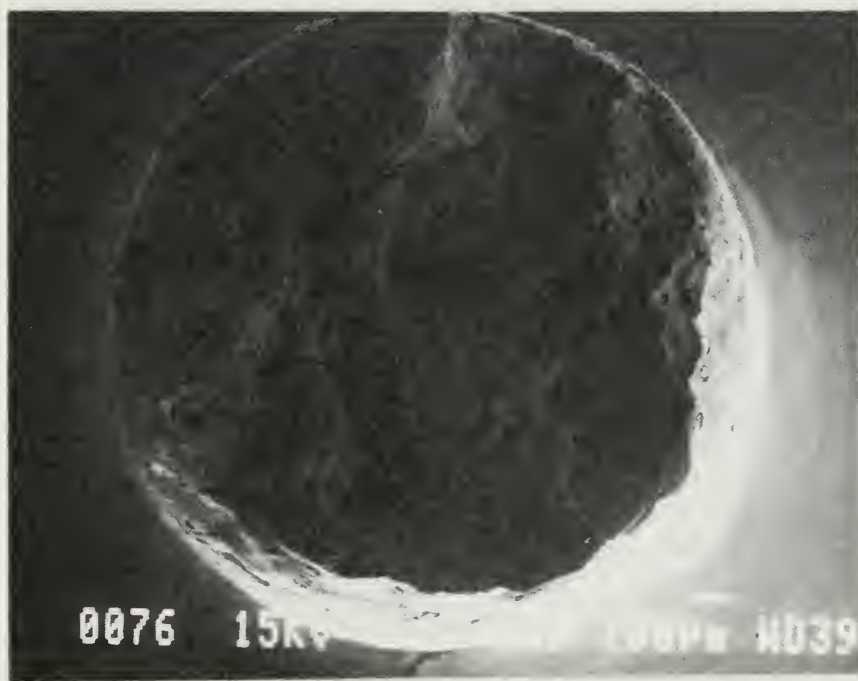
Figure 32 Photomicrographs of "Forged/Annealed" Alloy 625
Fracture Surface for Air Test Condition
Specimen 76

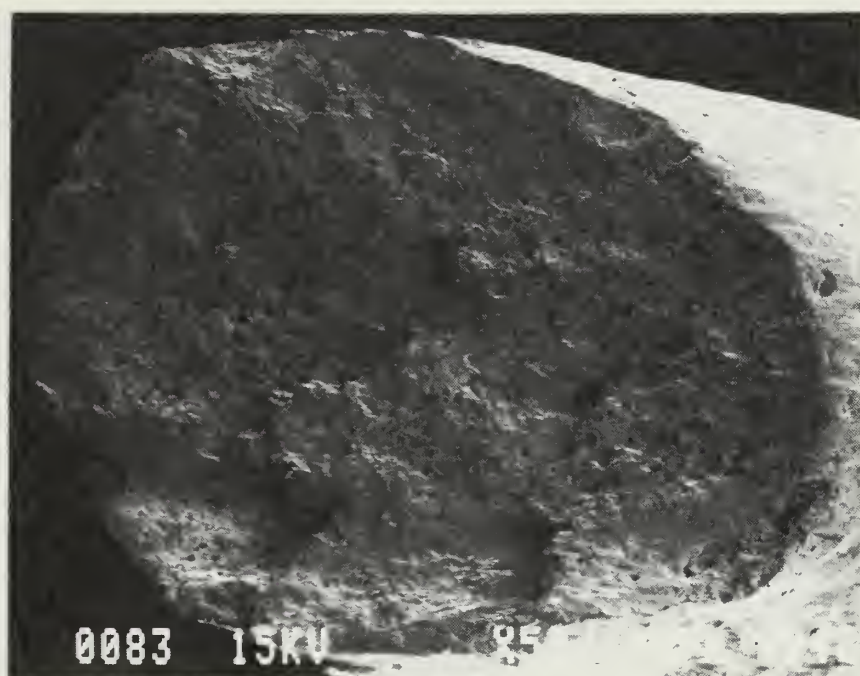
Figure 33 Photomicrographs of "Forged/Annealed" Alloy 625
Fracture Surface for -1.0 Volt Test Condition
Specimen 83

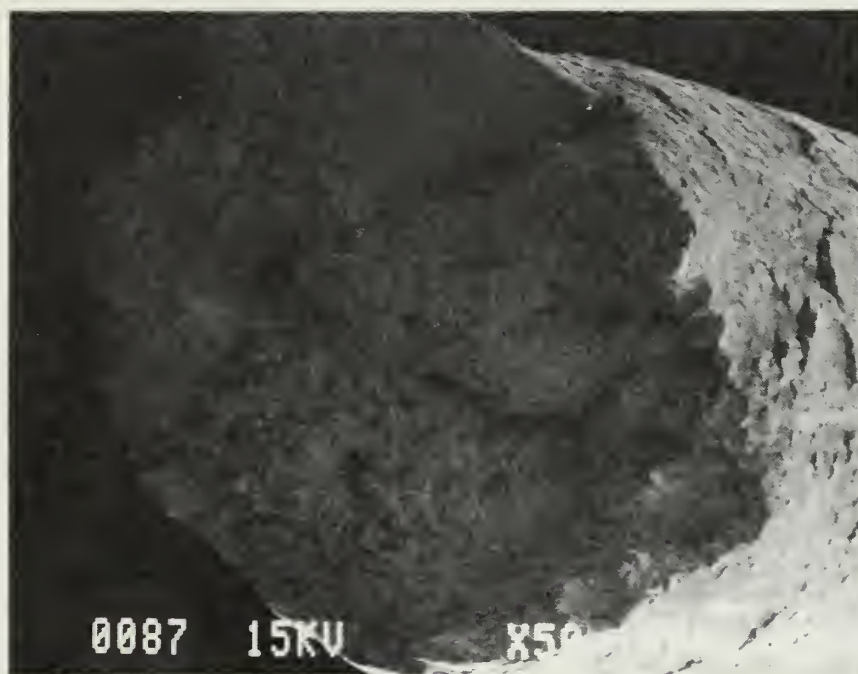
Figure 34 Photomicrographs of "Forged/Annealed" Alloy 625
Fracture Surface for -2.0 Volts Test Condition
Specimen 87

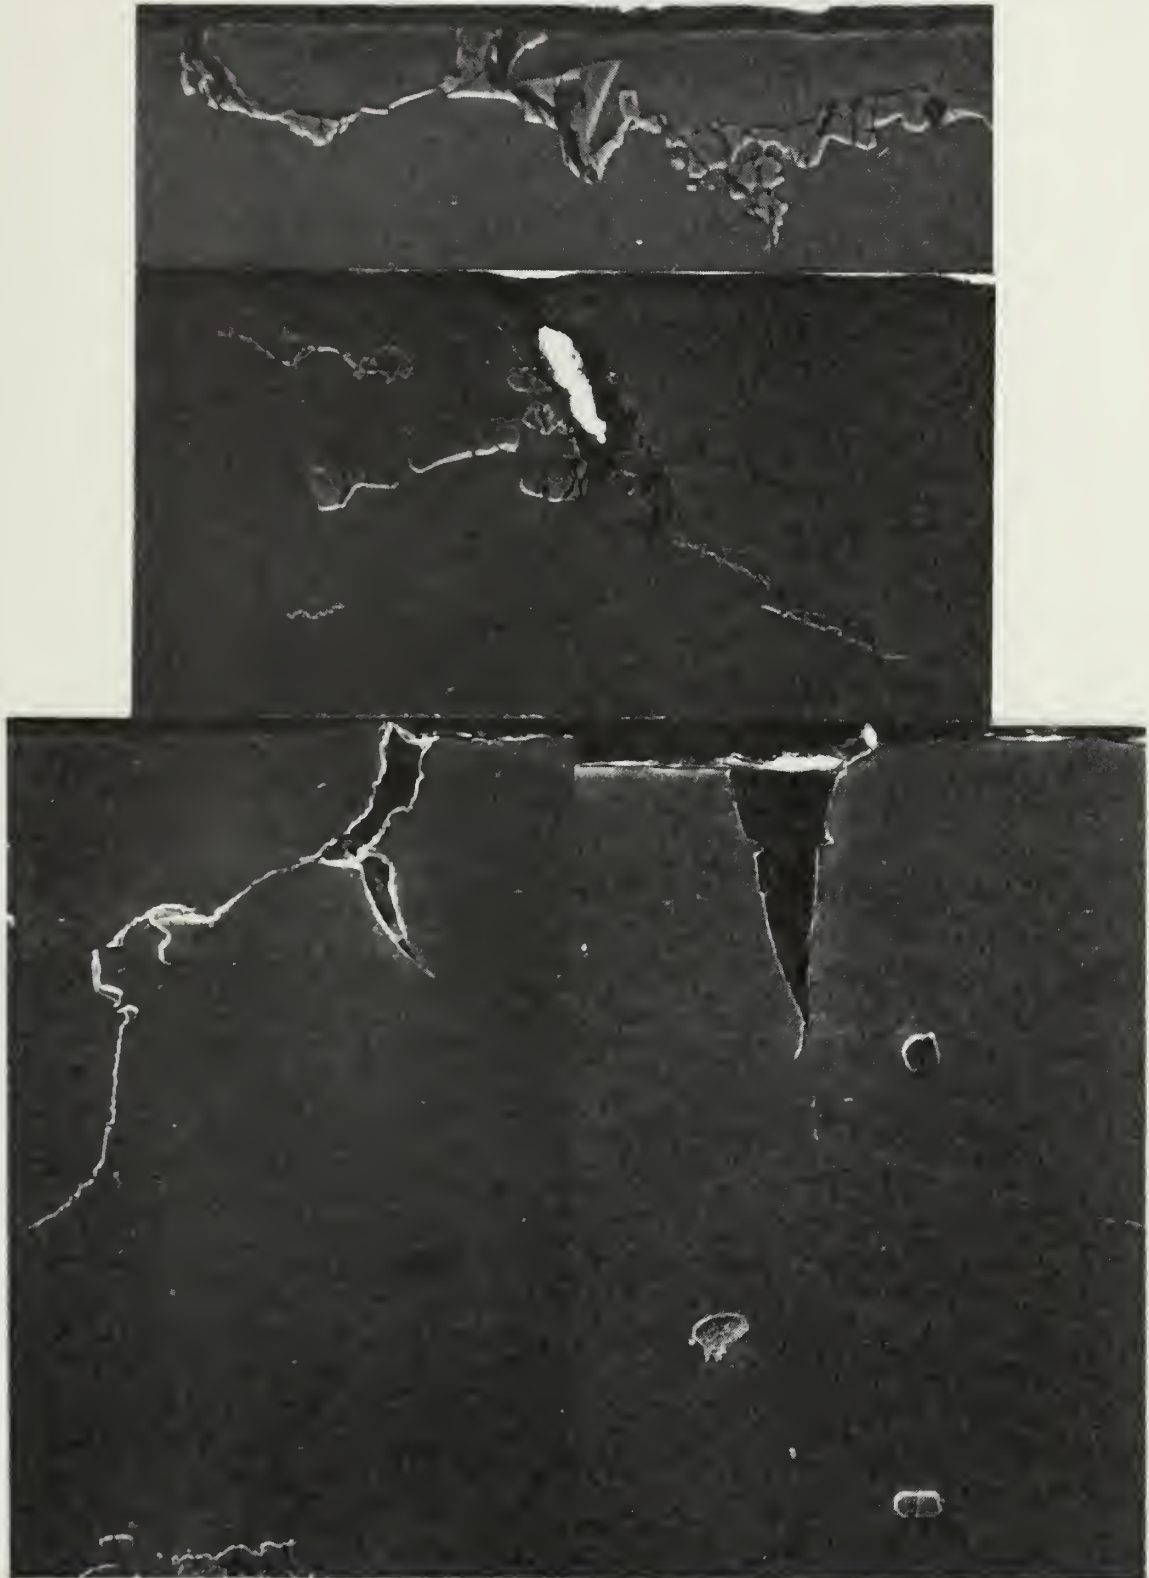
Figure 37 Photomicrographs of "As Cast" Alloy 625
Sectioned Gage Lengths for Air, -1.0, and -3.0
Volts Test Conditions - Specimens 4, 8, and 9
Top, Middle, and Bottom respectively
